St. _____
~~Pl.~~
 Ave. No. 30

Thomas
 Name of Owner
M. Lyford

Labor and Mat'l. Report 7 1987

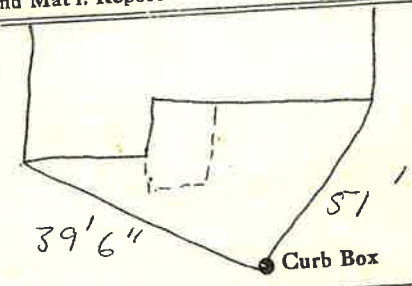
12' Main Elev. of Main at tap _____

Gate at • Gate at •
 ¾" Copper 21' to main

• Curb Box
