LABOR AND MATERIALS

Traver St. Pl. Ave. No. 15

Found to be Copper. Labor and Mat'l. Report June 27-28 1967

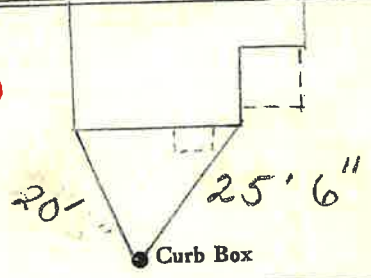
Main Elev. of Main at tap Gate at Gate at 12' to MAIN

Dug up at Curb for Renewal Tap and sound copper June 27+28-1967.
