EAST TREMONT ^{St.} _{Pl.} 26
Ave. No.

Name of Owner LARRY CLUTE

Labor and Mat'l. Report ~~49~~ 11/28/2007

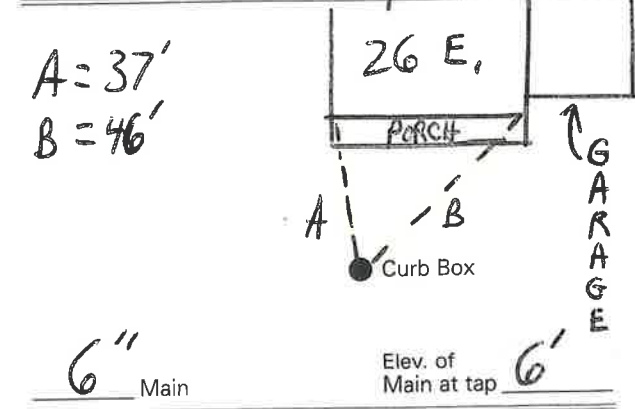
6" Main Elev. of Main at tap 6'
Gate at ● Gate at ●
TAX ID# 309.16-14-23.2

● Curb Box
