EAST TREMONT St.  
Pl. Ave. No. 29

Name of Owner  
TAX ID# 309.16-17-4

Labor and Mat'l. Report 5/15/13

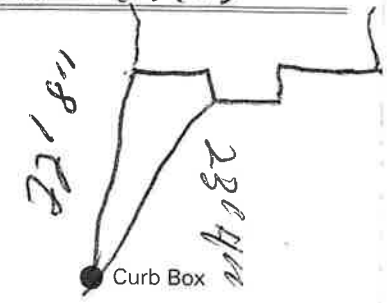
0" Main Elev. of Main at tap 5'  
Gate at ● Gate at ●

● Curb Box

outside clear out  
25 feet to main  
By w/w
