W. Tremont St. 23
 Ave. No. 29

Name of Owner _____
 TAX ID # 309.15-13-9

Labor and Mat'l. Report Dec 1989

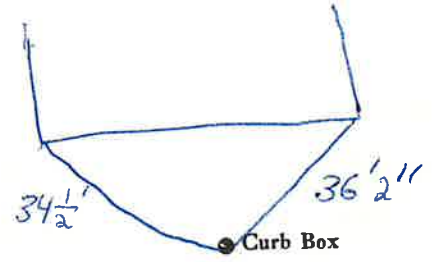
6 Main Elev. of Main at tap _____
 Gate at • Gate at _____
 3/4" copper 26' 27' 2" to main

• Curb Box
