Name of Owner

Gilbert Froncato

Labor and Mat'l. Report

June 10 1949

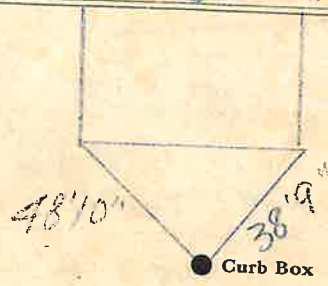
6 Main

Elev. of Main at tap 5

25' to main

$\frac{3}{4}$ copper

● Curb Box
