St. Pl.  
Ave. No. 21

Name of Owner Walter Cross.

Labor and Mat'l. Report Sept. 14 1960.

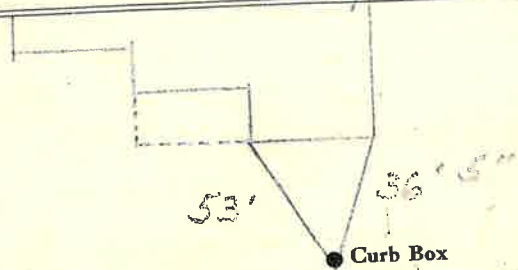
6" C.I. Main      Elev. of Main at tap 4'

27' to main

3/4" Copper ● Curb Box
