St. Walnut
Pt. Ave. No. 74

Dora M. Meyerson

Labor and Mat'l. Report

May 20 19*49*

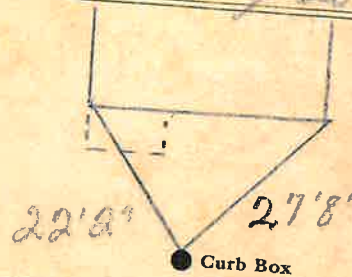
4 Main

3/4" copper 29'4" to main

● Curb Box
