St. 252 256  
Pl. -----  
Ave. No. 159

Labor and Mat'l. Report

July 29 1938

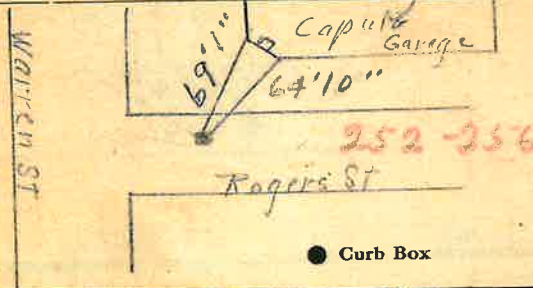
#254 TAX ID# 303.18-18-1

$\frac{3}{4}$ " Copper 22' to main

● Curb Box

New Tap

This Curb Stop is off  
When ON ~~off~~ Position  
ON
