WARREN

HOME FOR AGED WOMEN

Labor and Mat'l. Report

NOV 1945

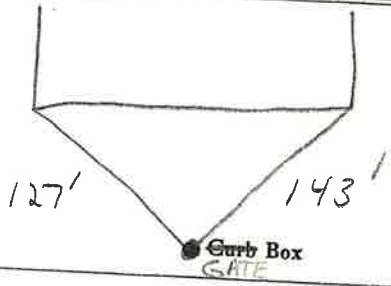
10 Main

Elev. of Main at tap 5 1/2

6" CI

7' to MAIN

● Curb Box

6" TAP
