Washburn ~~St.~~ Ave. No. 16

Name of Owner
TAX ID # 302.20-6-8

Labor and Mat'l. Report Aug. 2 1969

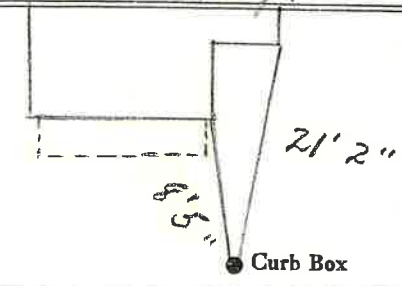
6" Main Elev. of Main at tap 6'

Gate at • Gate at
3/4" Copper 20' to main

• Curb Box
