31-141 **E23** Labor and Material Report Oct 5 1971

3/4" tap at 35 Washington at

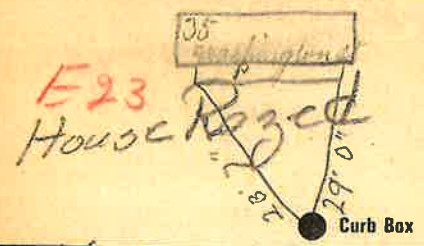
E23
House Razed
Now Used for hose connection
First National Bank Building
6" Main Elev of Main at tap 4 1/2

Gate at 3/4" copper 27' 40" MAIN Gate at

● Curb Box
Old tap shut off
TAX ID# 302.20-24-5
