~~St.~~
~~Pl.~~
 Webster Ave. No. 21

Name of Owner
 Lynn Chase

Labor and Mat'l. Report Nov. 4 19 59

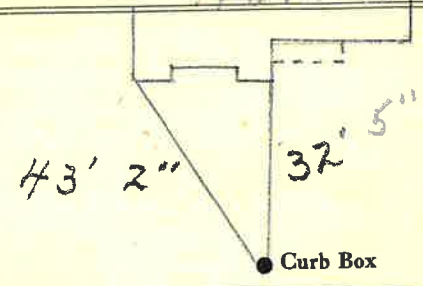
12" Main Elev. of Main at tap 4'

Gate at • Gate at
 3/4" copper 37' to main

• Curb Box
 TAX ID# 302.11-6-14
