LABOR AND MATERIALS

St. \_\_\_\_\_  
 PL. \_\_\_\_\_  
 Ave. No. 72

Name of Owner \_\_\_\_\_  
 TAX ID # 302.12-2-14

Measured in \_\_\_\_\_  
 Labor and Mat'l. Report May 12 1969

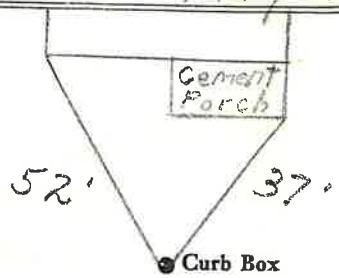
12" Main                      Elev. of Main at tap 5'

Gate at ●    ● Gate at

● Curb Box
