St. _____
Pl. _____
Ave. No. 75

Name of Owner _____
TAX ID # 302.12-17-9

Installed in 1964.

Labor and Mat'l. Report 19

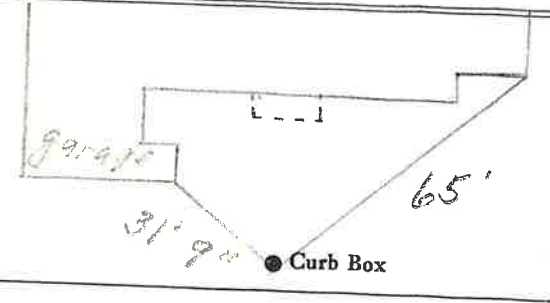
12" Main Elev. of Main at tap 4 1/2

30' to MAIN

● Curb Box
