LABOR AND MATERIALS

WEBSTER St. Pl. Ave. No. 83

Name of Owner
WEBSTER AVE, LIFT STATION

Labor and Mat'l. Report 18 6/24/2010

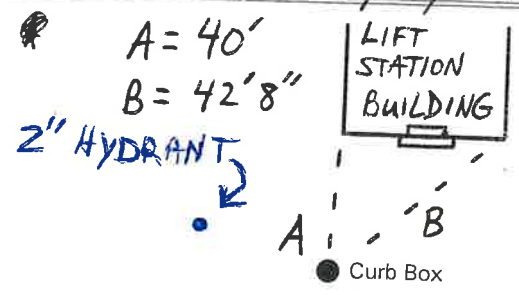
12" Main Elev. of Main at tap 5'6"

CURB BOX IS COVERED WITH A GATE VALVE COVER.

47' OF POLYETHYLENE PIPE TO THE MAIN.

HAS TRACING WIRE ON ALL POLY. PIPE
