LABOR AND MATERIALS

Western Ave. St. No. 32

Labor and Mat'l. Report July 31 1956

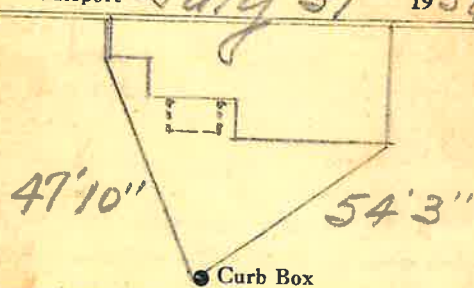
12" Main Elev. of Main at tap 2'

42' to main

• Curb Box

10/22 - Not on map
