BAY St. Pl. Ave. No. 100
 Name of Owner
 TAX ID # 302.20-6-3

Labor and Mat'l. Report 19

Labor and Mat'l. Report ~~X~~ 02-25-2003

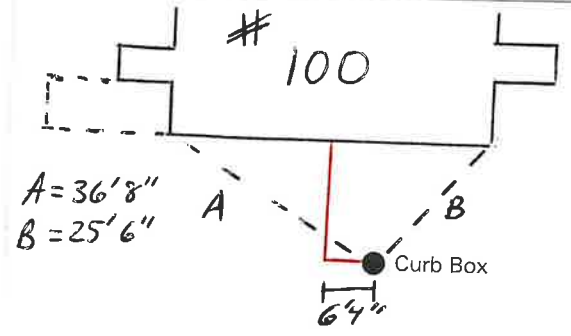
FROM CURB BOX, PIPING GOES 6 FT 4" LEFT.

THE WATER SERVICE IS "L" SHAPED.
* WHEN SERVICE IS ON IT WILL APPEAR TO BE IN THE OFF POSITION.

ALSO TRY - A=36'5" B=26'8"
