St. ~~Pl.~~  
Ave. No. 103

Labor and Mat'l. Report

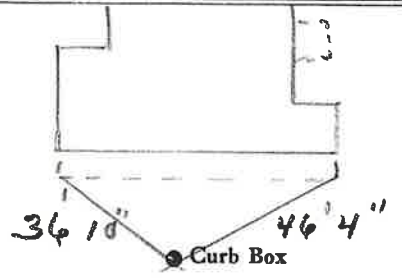
10 Main

Elev. of Main at tap 5

Gate at •

• Gate at

• Curb Box
