BAY St. 113
 Ave. No. 113
 Name of Owner
 TAX ID # 302.16-17-32

Labor and Mat'l. Report 1950

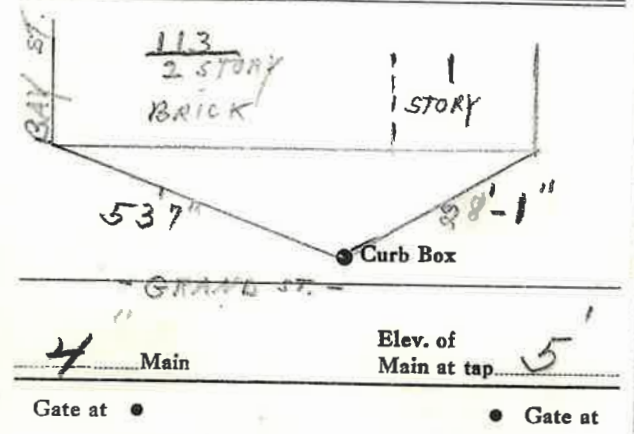
4" Main Elev. of Main at tap 5'
 Gate at • Gate at •
 Tap-on GRAND ST. • Curb Box
