BAY ST. St. PL
Ave. No. 134

Labor and Mat'l. Report 19

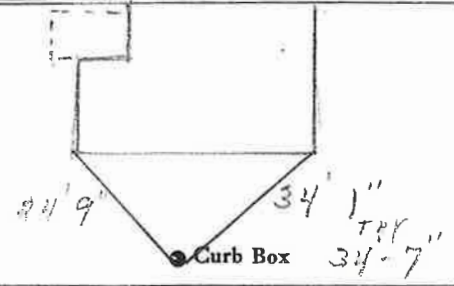
6 Main Elev. of Main at top 5 1/2

Gate at • • Gate at

• Curb Box

New $\frac{3}{4}$ copper - May, 1992
