LABOR AND MATERIALS

BAY St. PI. Ave. No. 138

Name of Owner
TAX ID # 302.16-12-13

Labor and Mat'l. Report 19

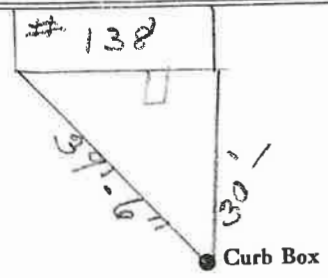
6" Main Elev. of Main at tap 5'
Gate at • Gate at •

• Curb Box
