LABOR AND MATERIALS

Name of Owner
 King (Albert)

Labor and Mat'l. Report Oct 5 1948

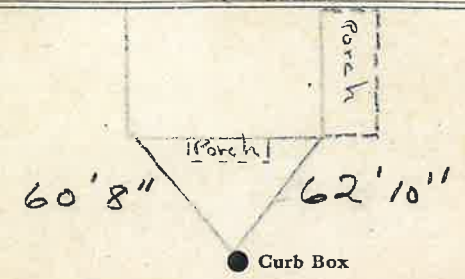
6" Main
 Elev. of Main at tap 3'

Gate at ● Gate at ●
 19' to MBIN

● Curb Box
 Tap on Side of
 Main, Service
 Pipe Down about
 4'
