LABOR AND MATERIALS

St. Chester
 Pl. 13-15
 Ave. No. _____

Name of Owner Salvation Army

Labor and Mat'l. Report Sept 4 19 62

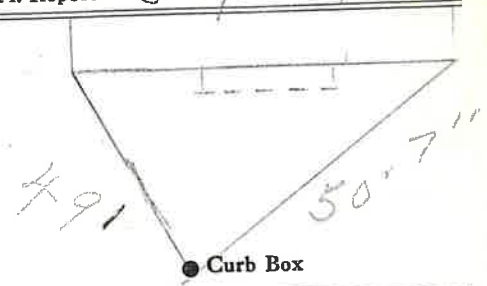
10" C.I. 7' Elev. of Main at tap 6'
 Gate at • Gate at

coupling → 20'
 10" C.I. • Curb Box 10' 21"
