LABOR AND MATERIALS

St. Cooper
~~Pt.~~
 Ave. No. 93

Labor and Mat'l. Report SEPT 21 1967

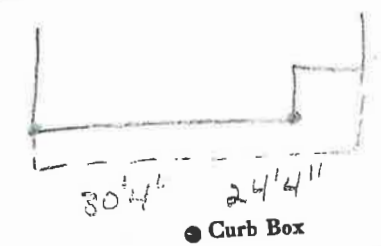
4" Main Elev. of Main at tap 5'

OLD TAP SHUT OFF
