St. ELM  
 Ave. No. 49

Labor and Mat'l. Report AUG. 1926

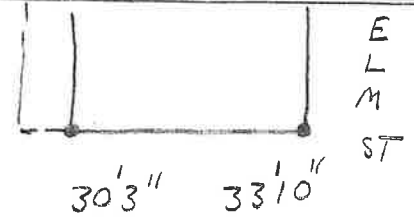
6" Main PINE ST.  
 Elev. of Main at tap 4'
