### LABOR AND MATERIALS

FAP-1951

St. PL. Ave. No. 13

Labor and Mat'l. Report 10 1951

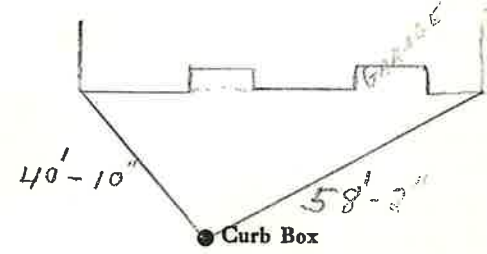
12" Main Elev. of Main at tap  $4\frac{1}{2}$

Gate at ● Gate at ●

● Curb Box
