St. W. Beacon
~~Pt.~~
 Ave. No. 31

Name of Owner
James Prundergatt

Labor and Mat'l. Report June 19 86

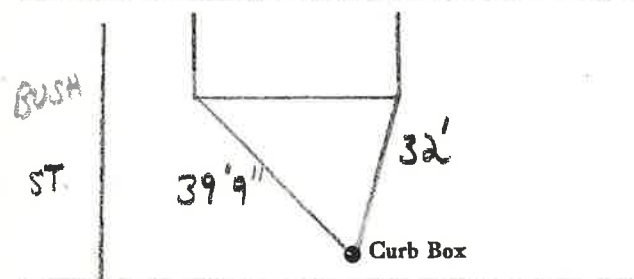
BEACON ST
 Main Elev. of Main at top 4'
 Gate at • Gate at •

• Curb Box
