St.  
Pl.  
Ave. No. 33

Robert Whipple

Labor and Mat'l. Report

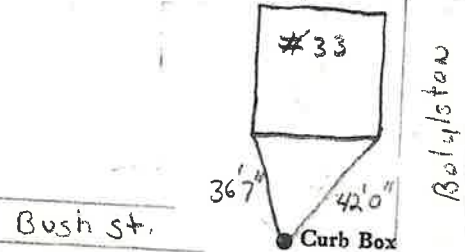
6" Main

● Curb Box

CURB STOP BEHIND FENCE -  
BUSH ST SIDE
