Broad

Name of Owner
Bertovitz

Labor and Mat'l. Report 7-31-39 19

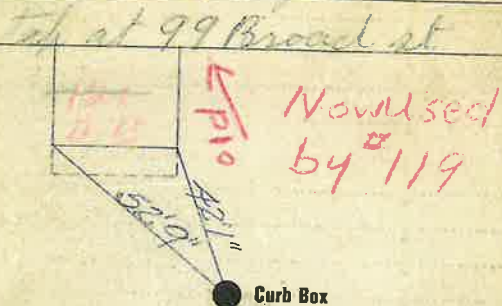
This House burned March-1953 and was Razed.

This Tap shut off at Curb + Curb box dug up & taken out. Curb stop under concrete Near Curb box for #119 or old #97
