Carleton Ct.
 St. Ave. No. 1

Labor and Mat'l. Report June 11/13 1956

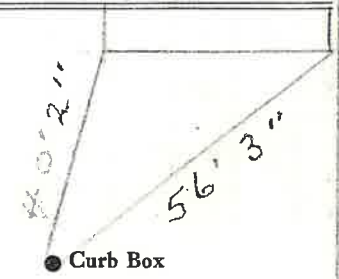
Carleton Ct.
 6" Main Elev. of Main at tap 5-8"

Measured from
 South Side of
 #1 Carleton Ct.
