St. Cataraugus  
 Ave. No. 7-9  
 Name of Owner John McQuira Boer

Labor and Mat'l. Report July 7 19 50

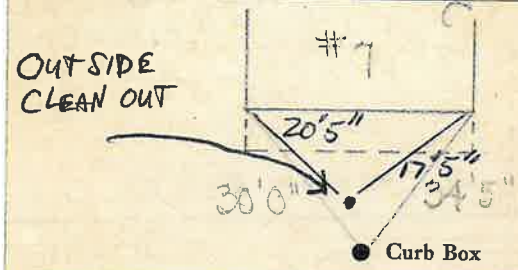
4" Main Elev. of Main at tap 5'  
 Gate at ● Gate at ●

● Curb Box  
 CURB BOX - "ON" POSITION  
 IS OFF
