St.             
Pl.             
Ave. No. 3

Labor and Mat'l. Report 19

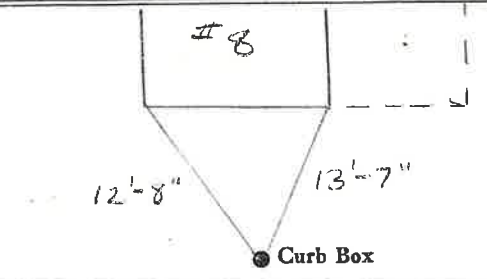
6" Main (1999) Elev. of Main at tap 5'

● Curb Box

Re-measured 7-20-78
