Crandall St. No. 7
 Pt. Ave.

Name of Owner
 J. Orlow & M. Alund

Labor and Mat'l. Report MAY-27 1974

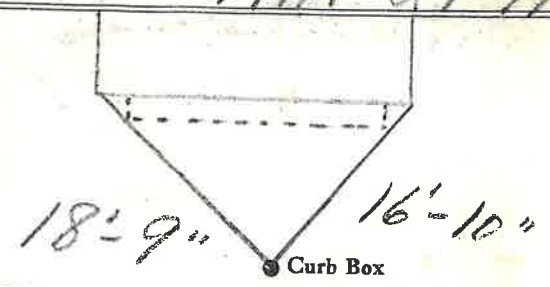
10" Main Elev. of Main at tap 5 $\frac{1}{2}$ '
 Gate at • Gate at •

• Curb Box
