LABOR AND MATERIALS

St.   
 -Pl-   
 Ave. No. 498

Name of Owner   
 Dr. John Stark

Labor and Mat'l. Report Oct. 30 1957

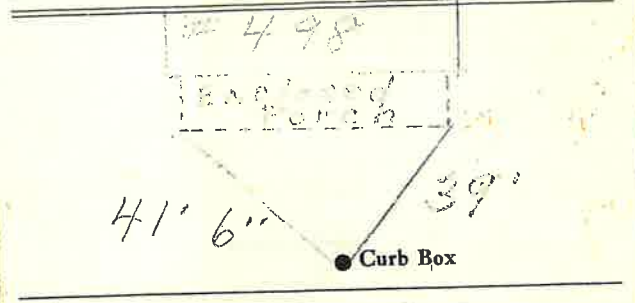
1 1/2" Main   
 Elev. of Main at tap  $5\frac{1}{2}'$

Gate at • • Gate at

• Curb Box
