St.  
Pl.  
Ave. No. 391

Name of Owner  
*William Canale*

Labor and Mat'l. Report *Sept. 22, 1978*

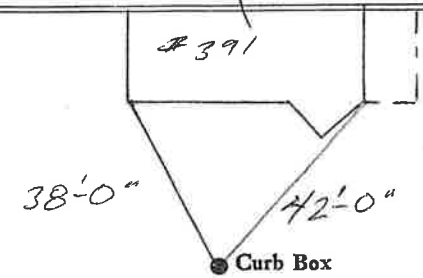
*12"* Main Elev. of Main at tap *5'*
