St. _____
~~Pl.~~ _____
 Ave. No. 24

Name of Owner _____
Mrs. Lyford

Labor and Mat'l. Report _____ 19 86

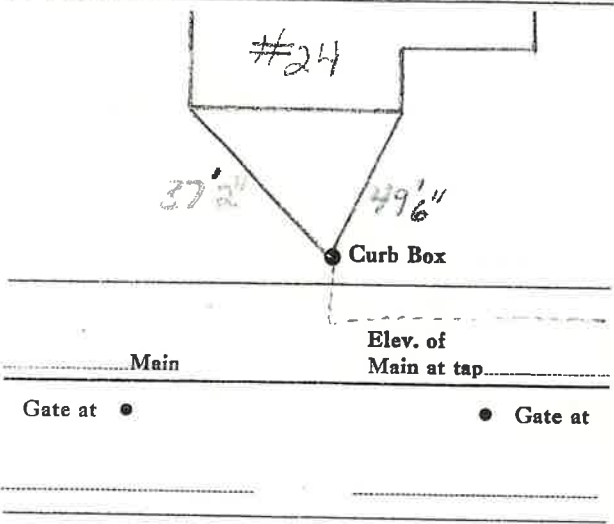
● Curb Box

TAPPED ON LEXINGTON IN
FRONT OF #60
