Grove ~~St.~~  
~~Pl.~~  
 Ave. No. 58

Name of Owner  
 Mead

Labor and Mat'l. Report Oct. 26 19 65

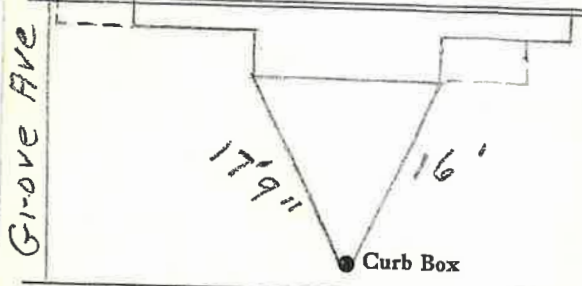
10" Main Elev. of Main at tap 6'

• Curb Box  
 This Tap is on  
 Crandall St.  
 Side,
