St. _____
 Pl. _____
 Ave. No. 19
Halsey
 Name of Owner Albert Ruxio.
 Labor and Mat'l. Report Oct. 24 1960

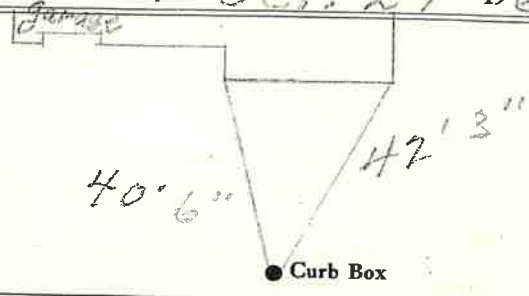
6" Main Elev. of Main at tap 4 1/2'
 Gate at ● ● Gate at
 ● Curb Box
 ● Curb Box
