Kernworthy <sup>Str</sup> <sub>Pl</sub> Ave. No. 12

Name of Owner  
Valeriano Castellucci

Labor and Mat'l. Report Sept. 22 1966

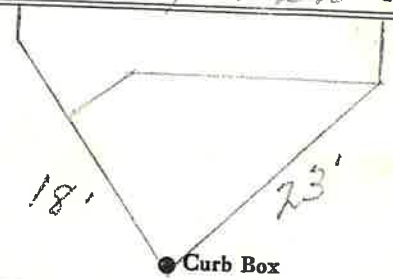
4" Main      Elev. of Main at tap 4-5'  
Gate at ●      ● Gate at

● Curb Box
