Knight St. Ave. No. 58

Name of Owner Bonam.

Labor and Mat'l. Report Apr. 12 19 71

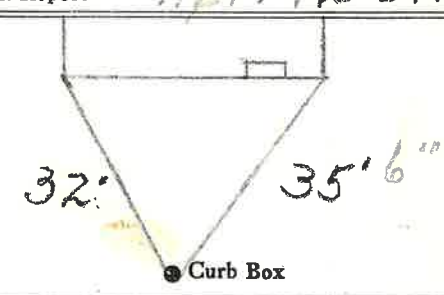
Main Elev. of Main at tap 5'

Gate at • Gate at •

• Curb Box
