Maple St. Pl. Ave. No. 16

Name of Owner  
Borden's Ice Cream Co.

Labor and Mat'l. Report Apr. 18 1955

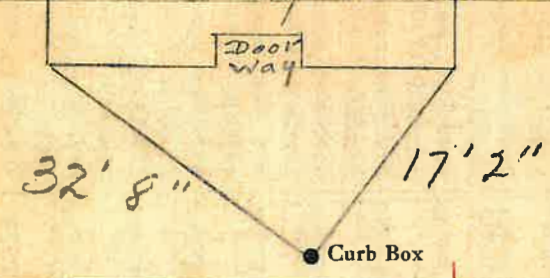
6" Main Elev. of Main at tap 5 1/2"

Gate at • Gate at •  
#16 - #18 TAX ID # 302.20-24-18  
• Curb Box
