Labor and Material Report

1920

143 Maple Street

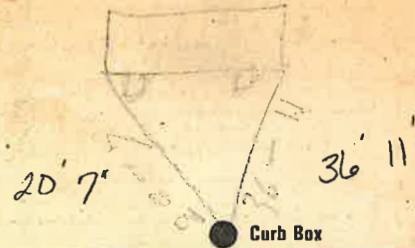
24' to MAIN

Curb Box

old tap disconnected
