Labor and Materials

Name of Owner *McDonald St. Daley*

Labor and Mat'l. Report *now* 9 19 37

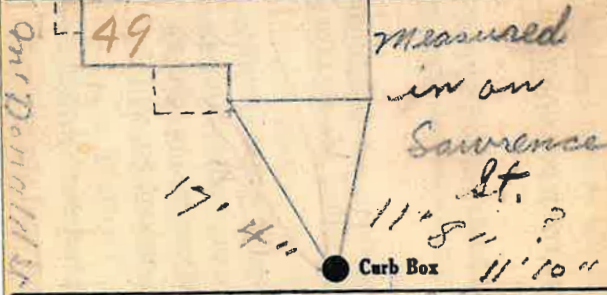
12 Main Iron Main Elev. of Main at tap 4½

Gate at • TAX ID # 303.18-1-11 • Gate at

● Curb Box

Old taps disconnected on McDonald St. by us this date.
