St. ~~Pl.~~
 Ave. No. 25

Name of Owner
 D. Frank Sullivan

Labor and Mat'l. Report Oct. 20 1969

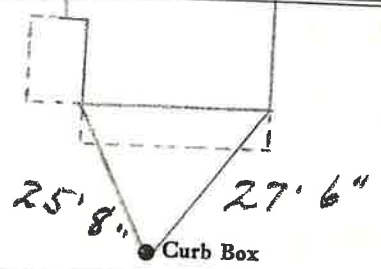
6" Main

Elev. of Main at tap 5'

• Curb Box
