LABOR AND MATERIALS

Name of Owner
 Geo. Harrington Jr.

Labor and Mat'l. Report July 26 19 61.

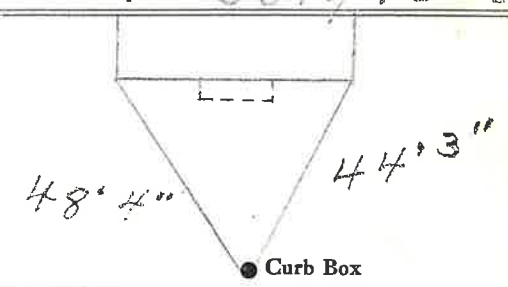
4" Main Elev. of Main at tap 5'

Gate at • Gate at

• Curb Box
