Labor and Materials

532-83 51 Labor and Material Report 1972

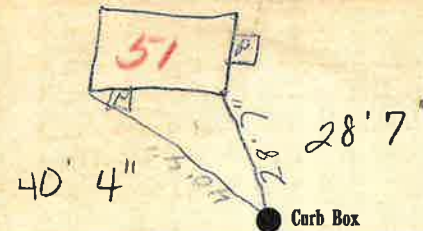
3/4 tap at 39' depth at

6" Main

Elev. of Main at tap 4.45

● Curb Box

Old tap not dug up.

3/4" copper
29' to MAIN
