St. Sagamore  
 Pl. Ave. No. 108

Labor and Mat'l. Report 2/4 2005

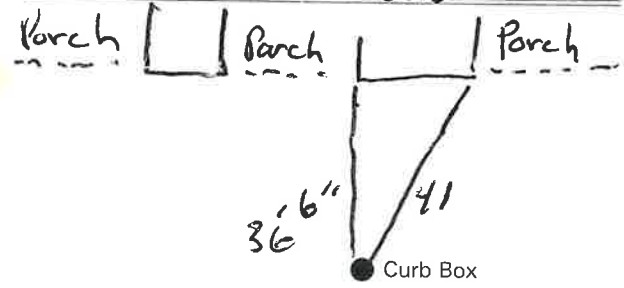
5' 3" Main Elev. of Main at tap 5' 2"

Gate at ● #110 ● Gate at

● Curb Box

1" copper
