St. Sanford
~~Pl.~~
 Ave. No. 205

Name of Owner
 Cooper

Labor and Mat'l. Report July 20 19 56

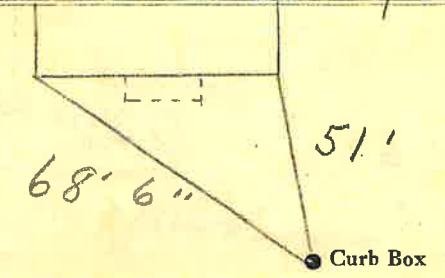
6" Main Elev. of Main at tap 4'
 Gate at • Gate at •

• Curb Box
 22' to main
 3/4" copper
