Labor and Material Report 26 Oct 1921

77 Sanford St to Tap

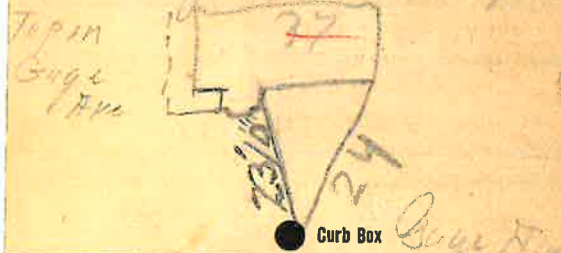
4 Main Elev. of Main at tap 4 1/2

Gate at ● TAX ID # 302.16-12-21 ● Gate at

● Curb Box
To Be dug up on Sanford St
The old connection

22' to main
